## ADSC '87 Civil Engineering Faculty Workshop

## Hayward Baker Inc. Takes on Yucca Loma Bridge

By Rick Walsh, P.E., GE, Business Development Manager, Hayward Baker Inc.

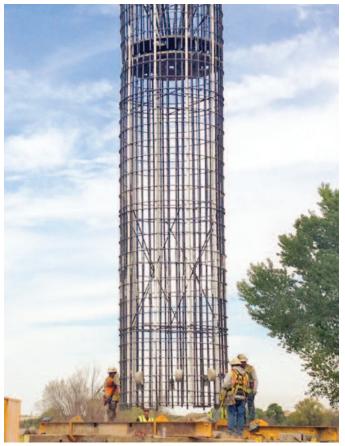
Placement of reinforcing steel for 120-inch-diameter shaft with O-Cell visible.

The first two 120-inch-diameter production piles were tested with O-Cells fitted in the reinforcement cages. The O-Cell tests were specified in the original project documents with intent of verification and optimization of the CIDH design. Each of the test piles was fitted with (6) 1,400-kip capacity calibrated O-Cells for a total test capacity of 8,400 kips. The location of the O-Cells was selected during the design process to evaluate both the end bearing and side friction characteristics and capacities of the geologic materials encountered. The elevation of the load cells was about 28 feet above the tips of each of these test shafts.

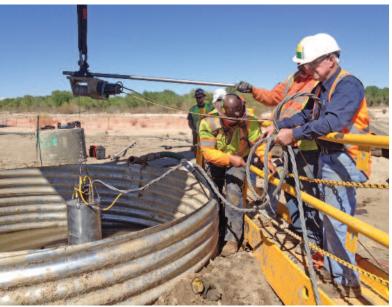
Inspection of 120-inch-diameter shaft with the Mini SID.

the manufacturer's requirements and circulated and/or replaced as needed to meet the satisfaction of the engineer. A Mini Shaft Inspection Device (Mini SID) was used to verify shaft bottom cleanliness. Each time the Mini SID was used the inspection results were deemed acceptable with no additional cleaning of the shaft bottom necessary. As a result of the demonstrated success of the shaft cleaning methods utilized by Hayward Baker after the first 15 shaft inspections the Mini SID requirement was waived for the remainder of the drilled shafts.

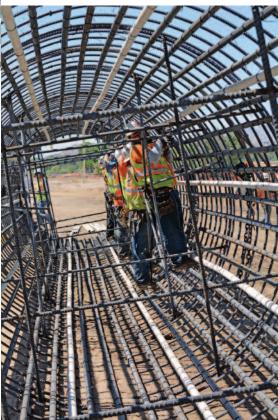
Installing PVC pipes (test tubes) for Gamma-Gamma testing after shaft construction.

Gamma-Gamma testing is conducted by lowering the probe into each PVC pipe (test tube) which were previously placed with the reinforcing cage. The probe consists of a radioactive source and detector that measures density of the placed concrete. This test method is primarily used to evaluate the concrete material within a few inches around the outside of each tube. Uniformity of readings indicates material homogeneity. When readings deviate too far from the mean bulk density of the concrete it may indicate a potential problem with the concrete such as voids or soil intrusion into the concrete. Typically when the Gamma-Gamma testing indicates an issue crosshole sonic logging will be conducted to further define the potential problem area. While the Gamma-Gamma testing is conducted in each individual tube thereby testing the immediately surrounding concrete, crosshole sonic logging is conducted between the different test tubes thereby evaluating the

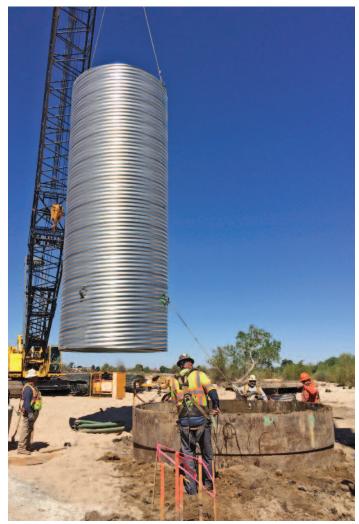
Preparing to lower the corrugated metal pipe into position.

consisted of 84-inch-diameter corrugated metal pipe (CMP) and for 120-inch-diameter drilled shafts the oversized casing consisted of 132-inch-diameter CMP. This CMP casing was installed to a depth of 15 feet below the drilled shaft cutoff elevation and extended above the ground surface approximately 42 inches to act as a safety barrier. The hole in which the CMP casing was installed was drilled to a diameter of 12 inches larger than the CMP diameter. The annulus between the oversized hole and the casing was backfilled with sand and cement grout. Drilling of the shafts was completed with a combination of a Soilmec\* SR 100 and the Big Stan drill rig originally fabricated by Hayward Baker's sister company Anderson Manufacturing.

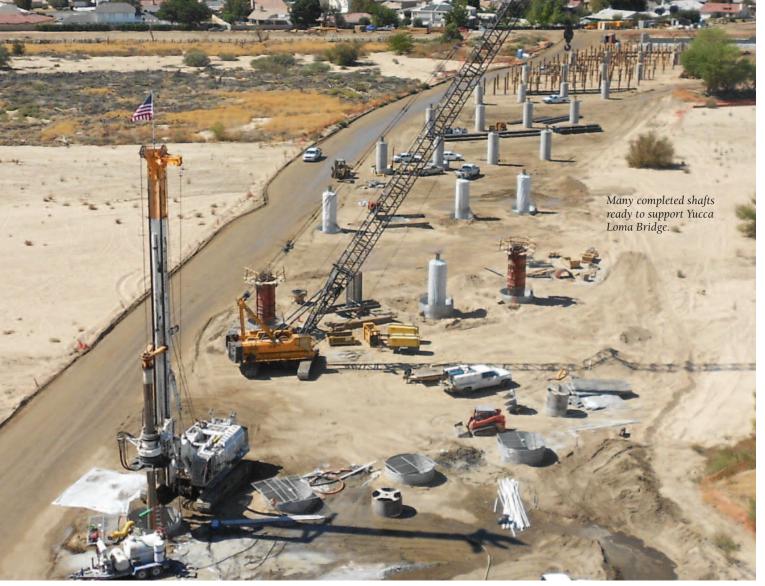
concrete between any two tubes. By combining these testing techniques potential issues with concrete placed in the shafts can be defined with a good degree of precision. Once testing is completed the test tubes are filled with cement grout.

On the Yucca Loma Bridge the non-destructive testing results indicated extremely successful concrete placement. The tests found no anomalies in any of the 60 tested piles.
